SERVICE BULLETIN

MODEL: 300

BULLETIN NO: 4

ADJUSTMENT OF AC SOLENOIDS ON RECORDERS BELOW SER. NO. 500

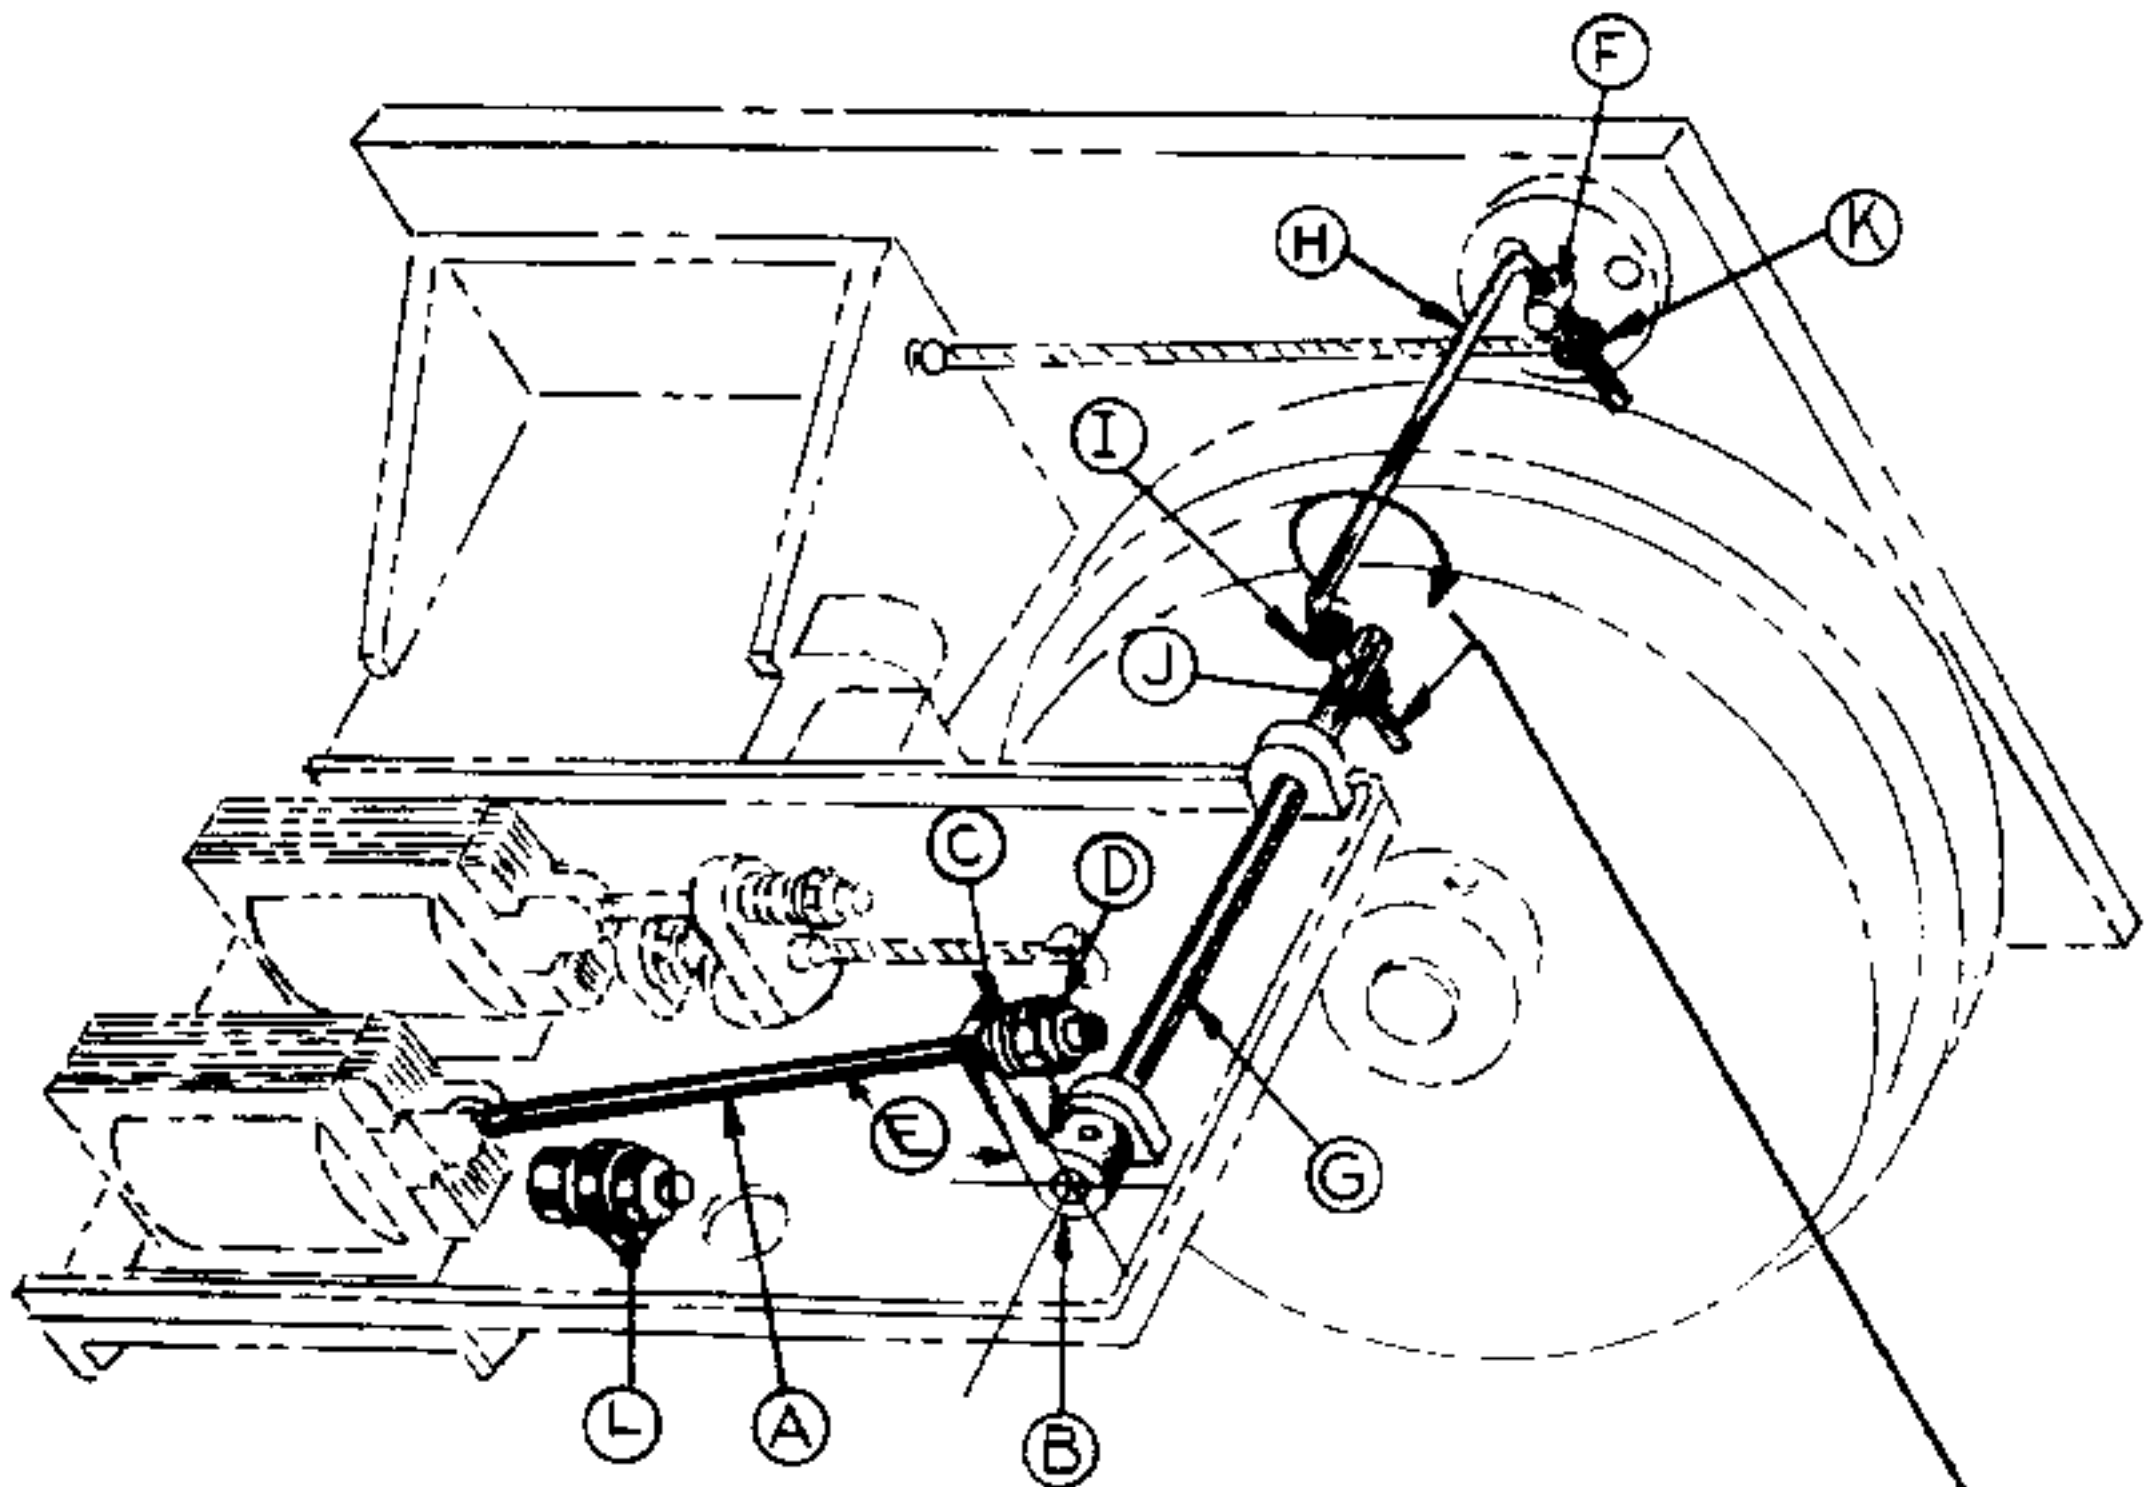
Some difficulty has been experienced with the humming or buzzing of the solenoid which operates the capstan idler, E801. Investigation of the cause of this noise has disclosed that if the linkage has not been adjusted properly, the force required of the solenoid will be greatly increased and therefore cause it to hum.

Looking at the drive assembly from the bottom, the linkage of the capstan idler solenoid can be seen. The link rod A passes through a hole in the arm B that it operates, and there is a rubber washer (C) and adjusting nut (D) on the end. When the solenoid is operated, the rod pulls the rubber washer against the arm to operate it. When the solenoid is seated, the angle E between the rod and the arm should be less than 90° . If this is so, the effective contact point of the washer is on the outside. If the angle between the rod and the arm is greater than 90° when the solenoid is seated, the contact point of the washer on the arm is on the inside, effectively reducing the moment arm by a considerable amount, and therefore requiring much greater force to be exerted by the solenoid.

The importance of maintaining the above angle E below 90° was only recently discovered, and it is possible that some machines have been shipped in which this angle might be too great. While no machines have been shipped with noisy solenoids, it is possible that if the above adjustment is not proper the solenoids may become noisy in use. Should this be the case, the adjustment can be corrected as follows:

ANGLE E MUST BE LESS THAN 90° WHEN
CAPSTAN SOLENOID IS SEATED.

It will be noted that the capstan idler arm shaft F is connected to the operating shaft G below through a U-shaped torque link H. If the bottom (or shorter) arm of this link H is bent in a clockwise direction (when looking at the link from the bottom or short arm end), this will effectively reduce the angle E. In order to bend this arm, it is necessary to remove link H and hold it in a vice. The link can be removed by forcing off the spring-lock washers which position the lower arm (I and J) and which attach the return spring at the top (K). The proper value for the angle E is approximately 85° , or when the arm H is perpendicular to the plane of the solenoid base plate.

If the angle E is changed, it will be necessary to re-set the capstan idler adjustment D. This adjustment is set so that when the capstan idler just touches the capstan, the solenoid is $1/8$ inch shy of seating. A simple way of making this setting is to place a piece of material $1/8$ inch thick between the solenoid armature and body and clamp the armature down on it. Then tighten the nut D until the capstan idler just touches the capstan.

It may also be necessary to reset the capstan idler solenoid Stop L. This stop should be set so that at no time during fast winding does the tape touch the capstan idler.

TO REDUCE ANGLE E, BEND
THIS ARM CLOCKWISE WITH
RESPECT TO UPPER ARM. RESET
ADJUSTING NUT D & L.
