SERVICE BULLETIN

DATE: 20 March 1953
MODEL: 300
BULLETIN NO: 8
PAGE NO: 1

PLUGGING OF CAPSTAN OIL
HOLE ON RACK MOUNTED
UNITS

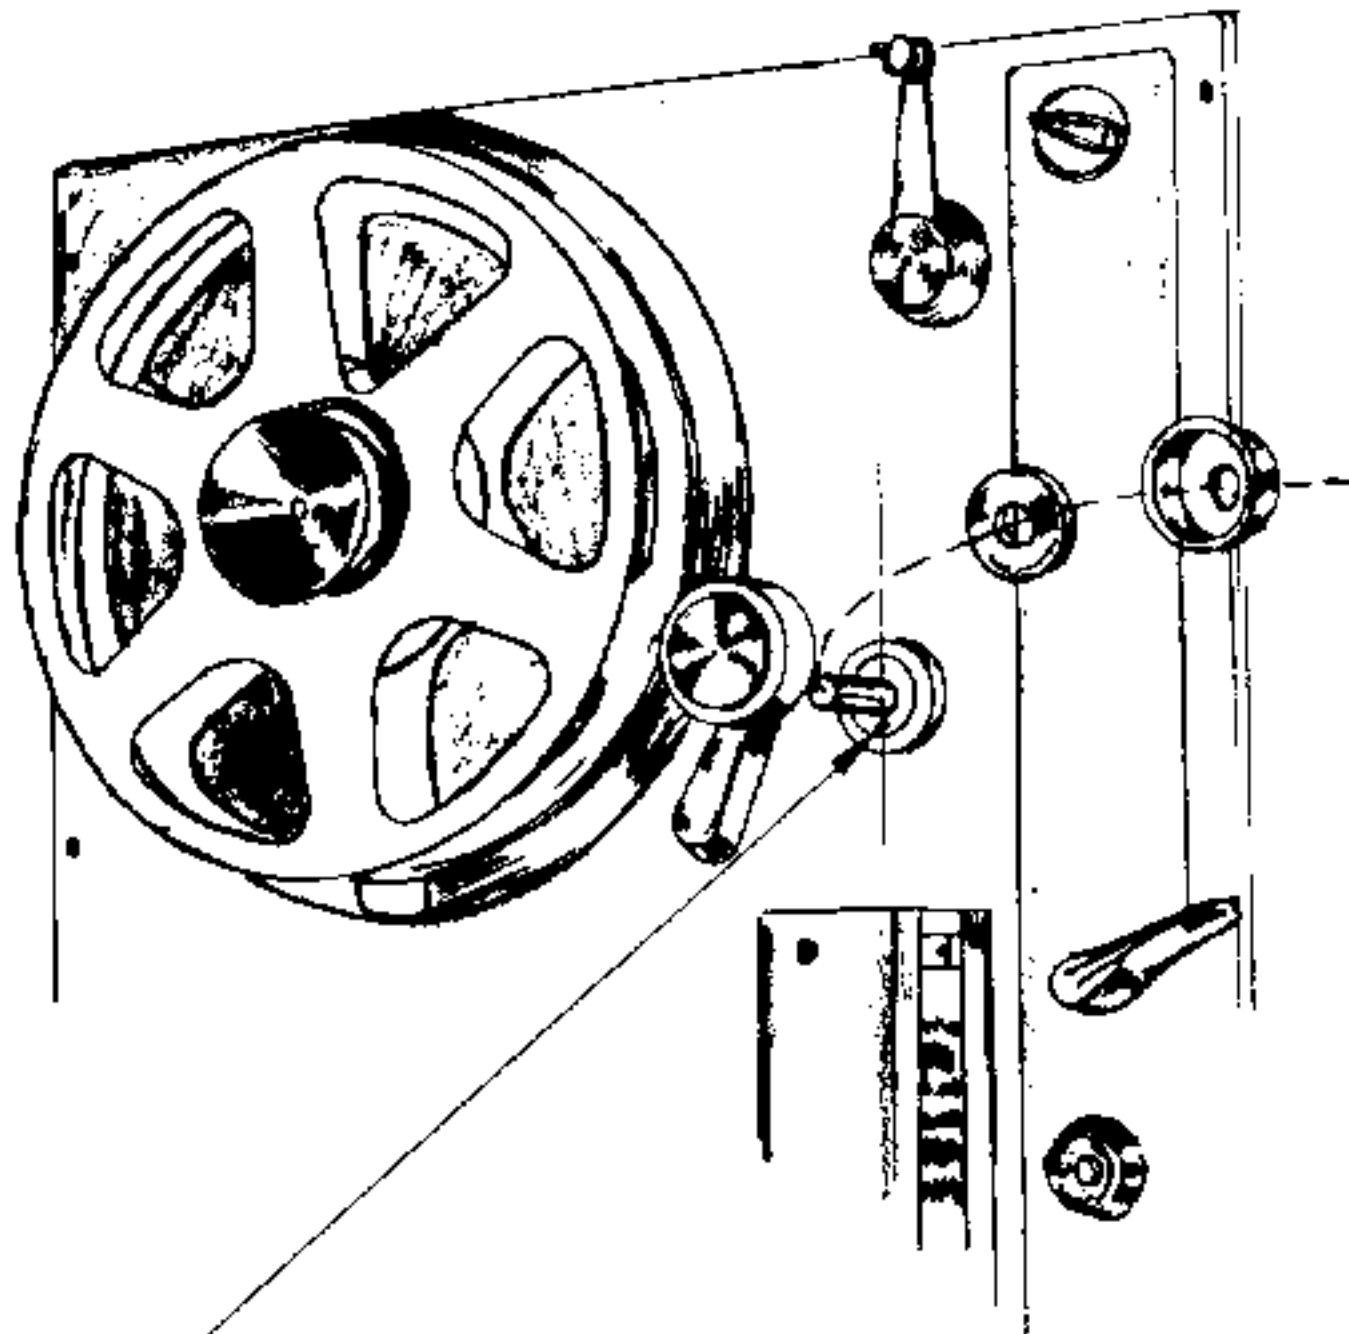
1. Capstan Oil Leakage. There is a tendency for oil to climb out of the capstan bearing housing during the first few weeks of operation. The capstan bearing has been thoroughly impregnated with oil so as to drive out any air inclusions, as the presence of air would tend to force oil out of the bearing housing when it becomes warm. The excess oil present climbs up the capstan when the machine is operated. Ordinarily, this oil is caught by the felt washer on top of the bearing housing. (The neoprene washer shown in fig. 2 of the instruction book was eliminated in production because it produced flutter.) If this washer becomes saturated with oil, which usually happens, then it will no longer behave as an effective seal. Therefore after the first week or so of operation, when most of the excess oil has had a chance to work out, the felt washer should be removed and washed out in carbon tetrachloride. Simply remove the capstan dust cap (see fig. 2, instruction book) to remove the felt washer. If this washer is kept reasonably dry, then no trouble should be experienced with oil creeping up the capstan.

REMOVE CAPSTAN DUST COVER
& FELT WASHER AS SHOWN
POSITION CAPSTAN ASSEM.
SO THAT CENTER LINE BETWEEN
BOTH HOLES IS VERTICAL WITH
LARGE C'SK HOLE ON THE
BOTTOM AS SHOWN. IF CAPSTAN
SHOULD NEED POSITIONING SEE
SVC. BULL. *14
TAP 6-32 N.C. IN LARGE C'SK HOLE
INSERT 6-32 X 1/4 LG. FLAT HD. MACHINE
SCREW.
